# Sony Product Notification

**Model: MDR-NC50**

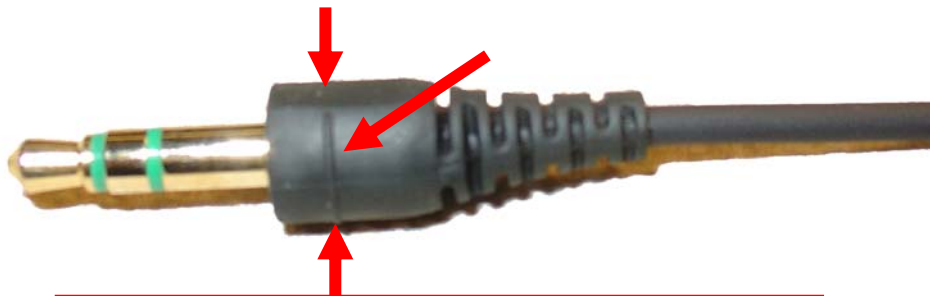
**The plug must be inserted up to this line.**

The cord should be firmly inserted up to the marked line resulting in a loud and clear click.

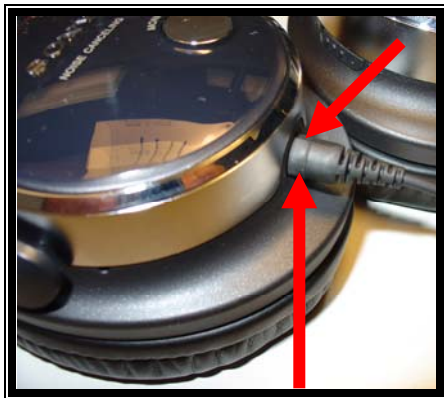
### **INCORRECT**

The plug is not completely inserted in the jack. The line does not meet the headphone jack.

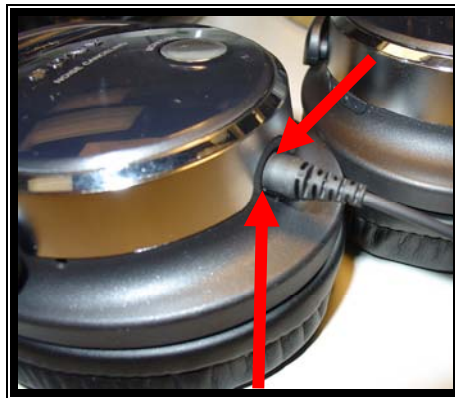
### **INSERTED CORRECTLY**

The line is right up to the headphone jack.
